22 November 2024

Our Ref: D2024/130885

Re: Cataract Dam SHR Number 01359

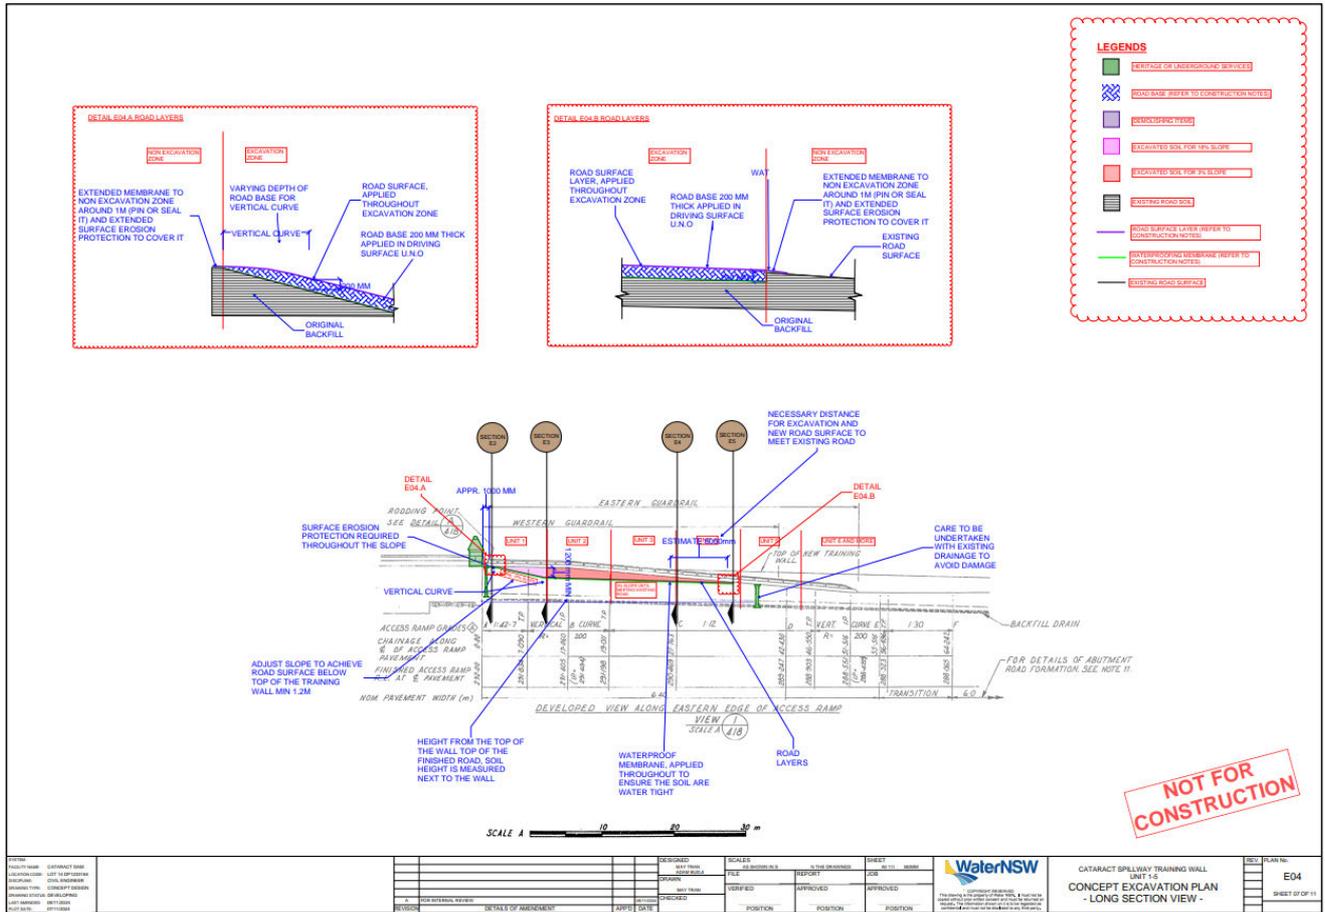
Figure 1 : Concept Excavation Plan - Long Section View

Stockpiling of new and used materials will occur on the left abutment of the dam. A general concept of the excavation plan and location of stock piling is shown in the Attachment.

1. Preliminary geotechnical investigations.
2. Excavate approximately 0 to 1.5m of soil from behind wall panel units 1, 2, 3 and 4 of the dam spillway training wall using a small size excavator to reduce the pressure.
2. Using saw cutting methods, remove concrete barriers along the roadway.
3. Install drainage to divert water to existing surface drains on site.
4. Reinstall temporary material within the excavated area to allow for emergency access and response.
5. Compact the road using non-vibration methods.
6. Dispose of waste materials.
7. Provide safety signage and barriers.
8. Install temporary portable jersey barriers on road, where concrete barriers were removed.
