**KEEPIT DAM UPGRADE WORK PACKAGE 1**

**CONSTRUCTION COMPLIANCE  
REPORT FINAL**

**February 2011 to September 2011**

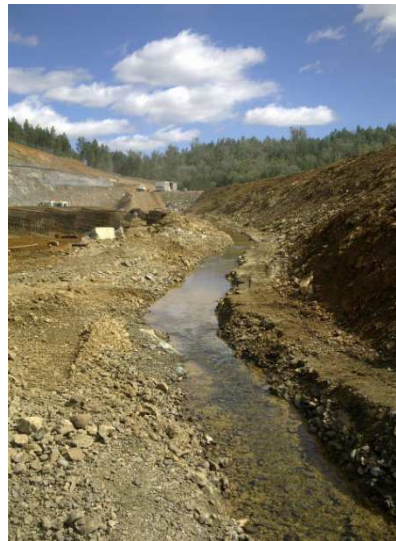
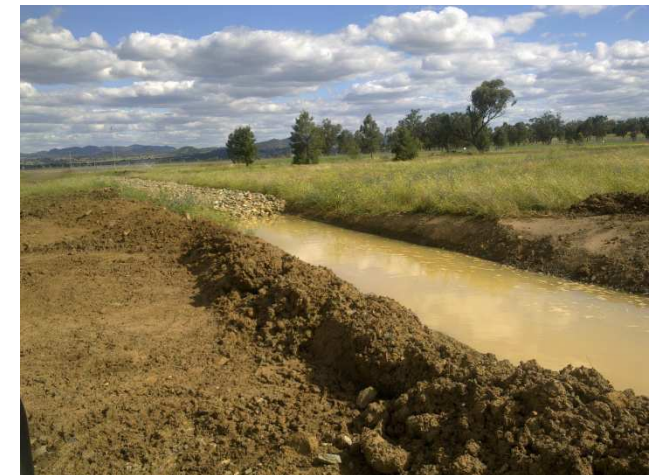
Since the beginning of the project sediment and erosion controls have been progressively installed in work areas as required. All erosion and sediment controls were in place prior to clearing and grubbing with the exclusion of the sediment basin at the right abutment. Minor clearing work for roads and stockpiles had commenced prior to installation of the sediment basin.

Labourers are sourced as needed from the general workforce. The PER is also equipped with basic equipment to correct easily fixed problems on regular inspections.

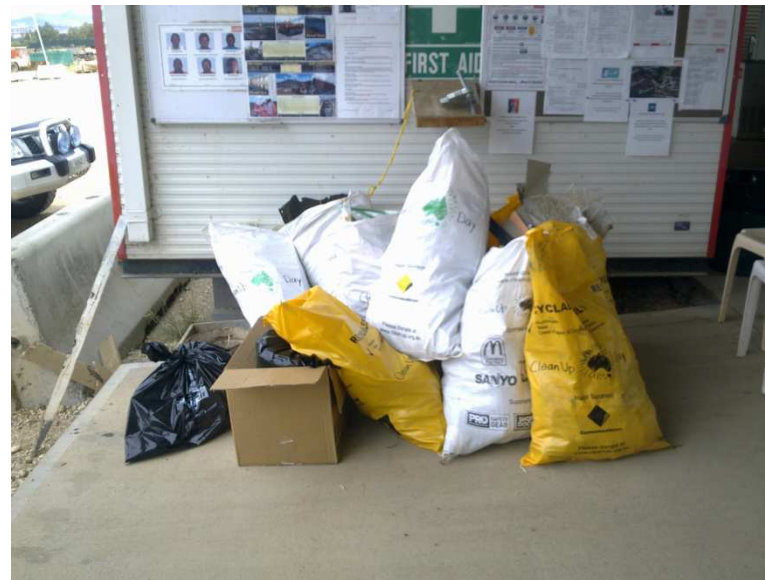
During the period of August 2010 to June 2011 the waste generated on site increased as the type of work being done changed from mainly excavation to building structures. The percentage of this that was recycled increased from 15% to almost 50% of waste generated.

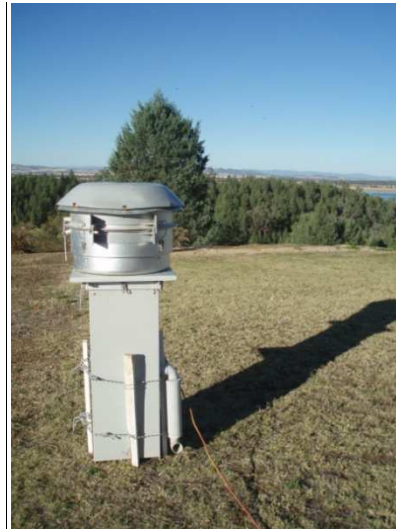
The Project acknowledges the potential for dust to be generated from site and has engaged the full-time use of water trucks to address the issue. The months of August 2010 and January 2011 reported an exceedance of dust criteria within gauge 2. The exceedances were attributed to unusually high levels of combustible matter in the gauge.

With the installation of a water fill point at the Right Hand Abutment, the water carts are able to more effectively spray the public roads between the site office and RHA. This made it possible to keep dust to an acceptable level during the summer months.
