Annual Water Quality Monitoring Report

2020-21

Figure 0.1: Sydney catchment area

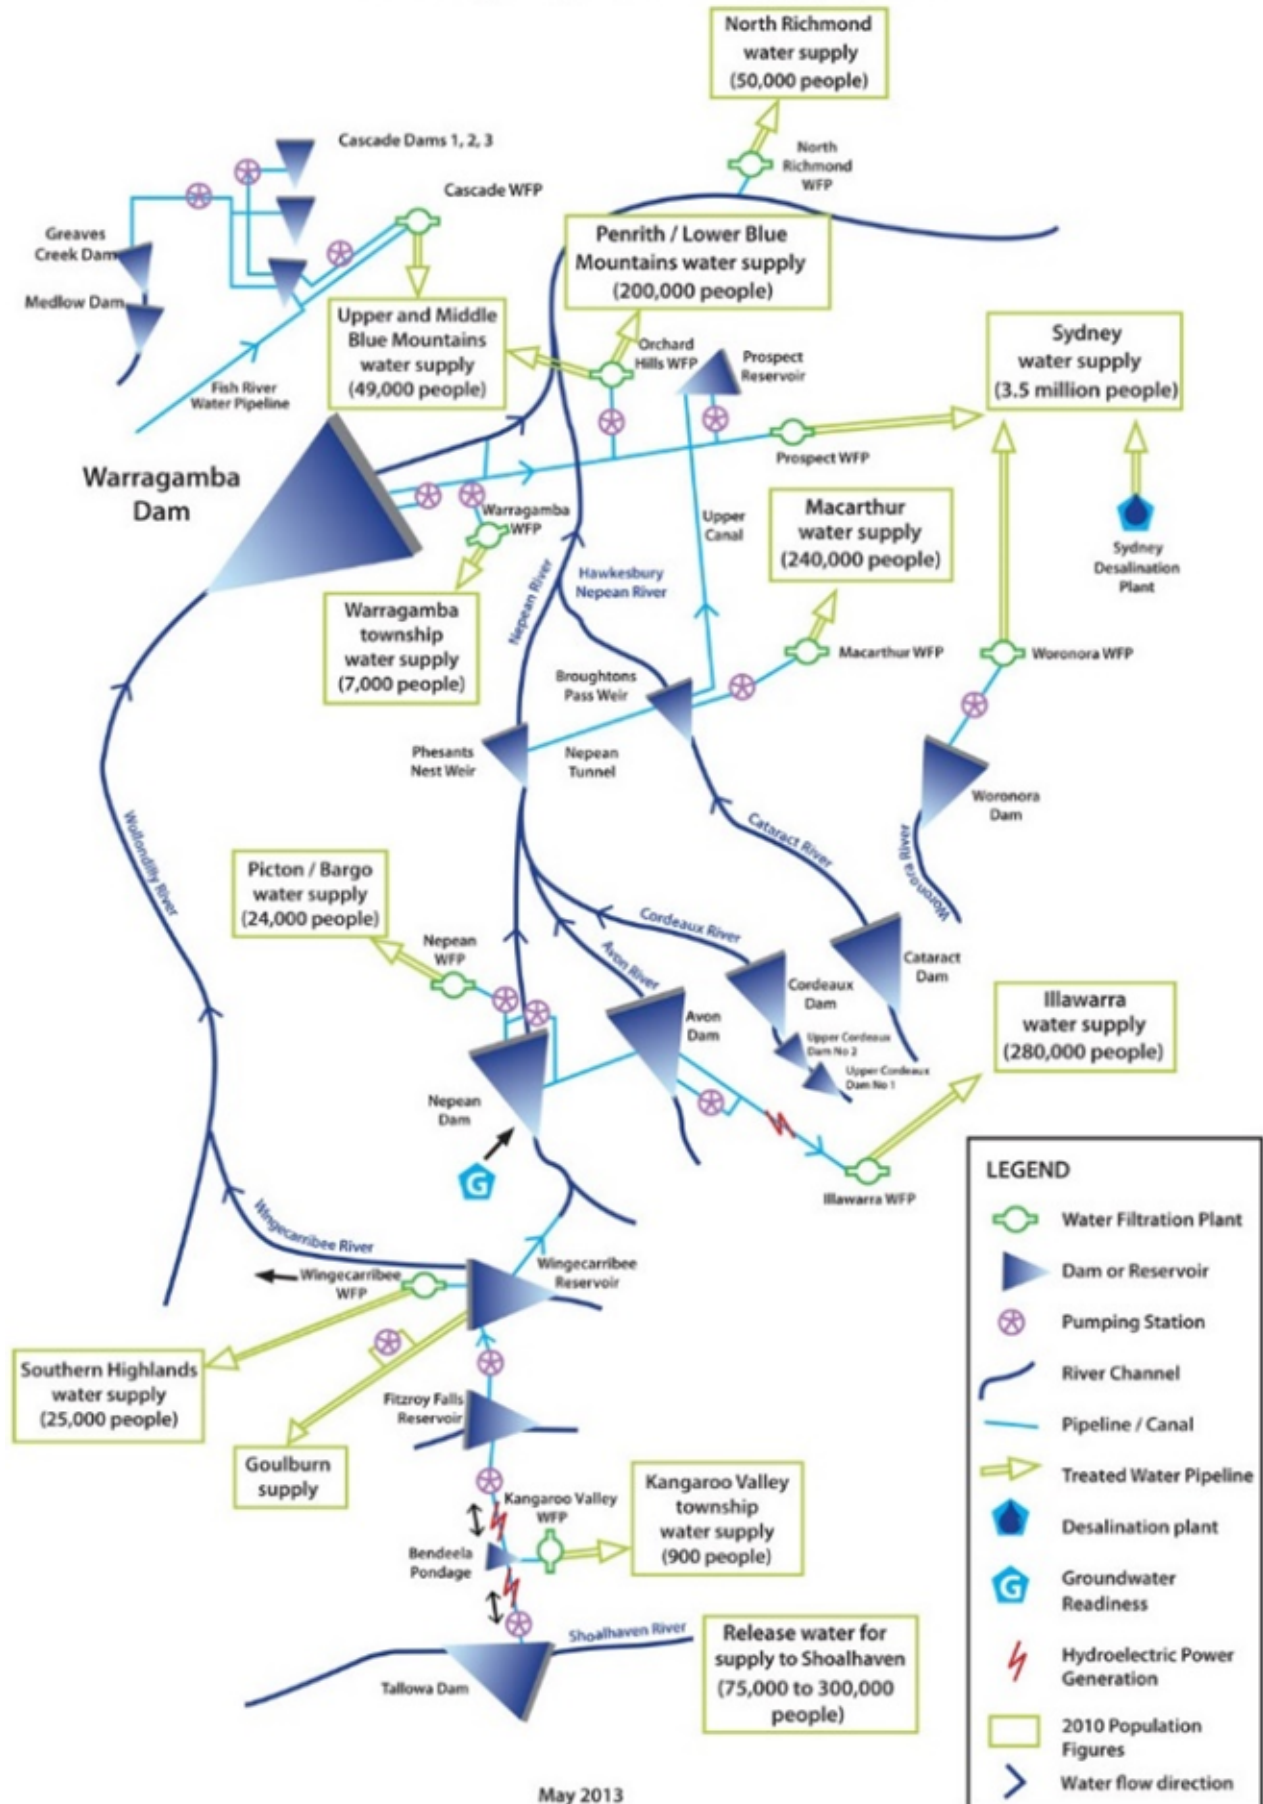
Figure 2.1: Schematic of the water supply system

The transfer routes for water around the system and approximate number of people supplied by that part of the system are shown in the water supply system schematic (Figure 2.1).

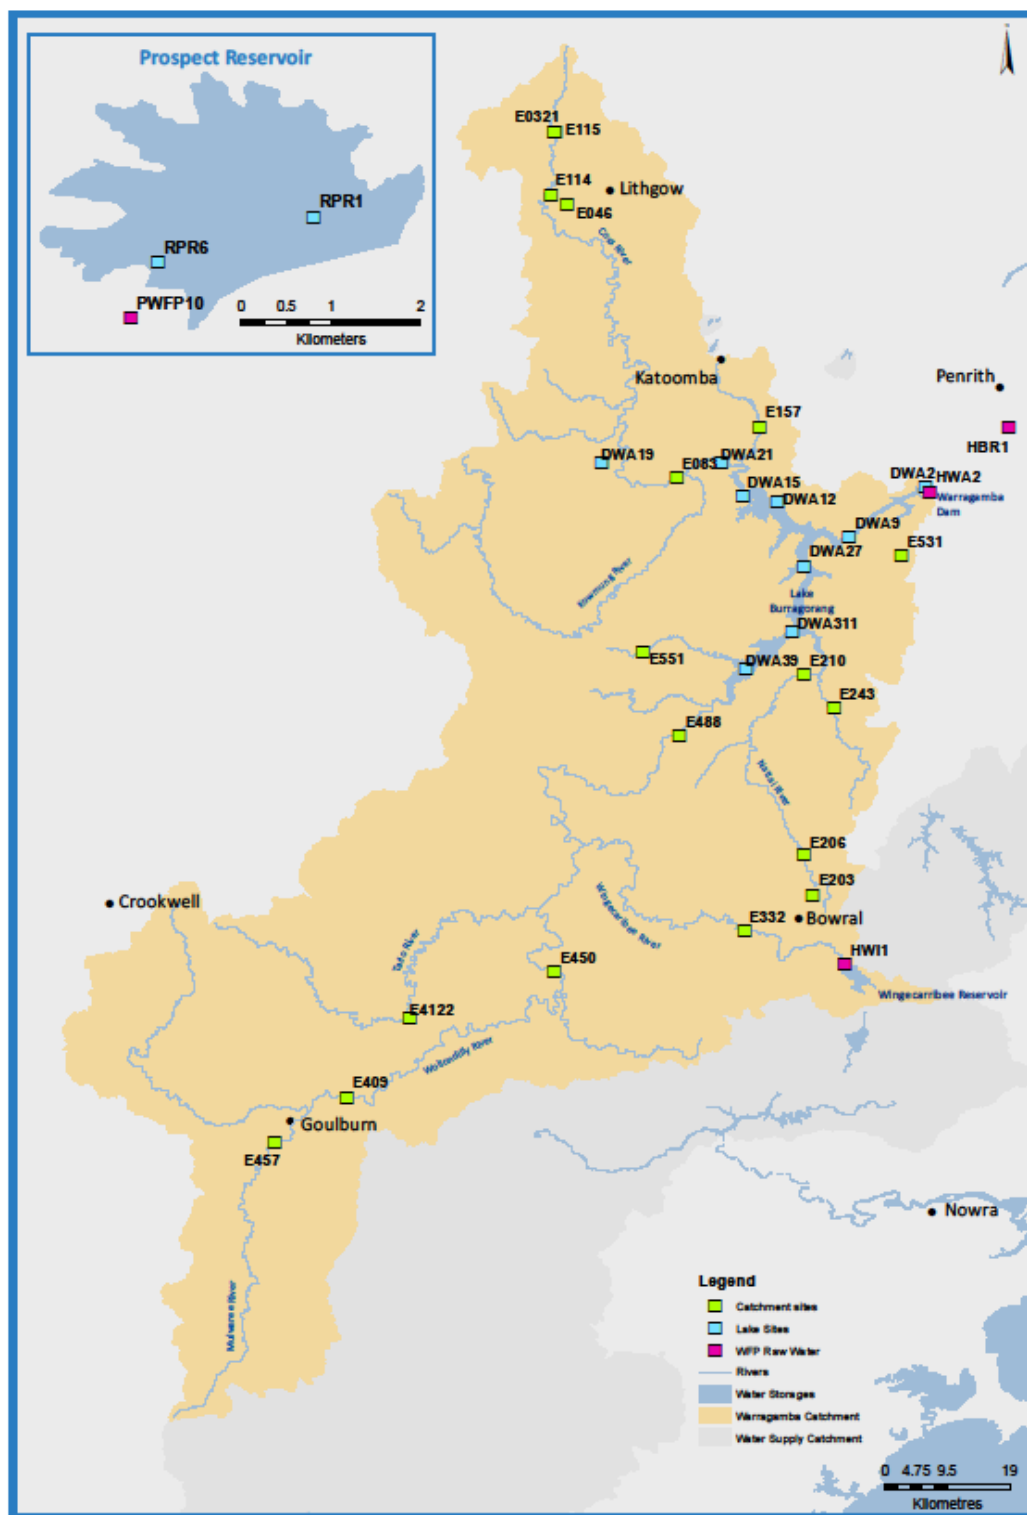
Figure 5.1: Sampling sites in the Warragamba system (Prospect Reservoir inset)

Sampling sites in the Warragamba system (including Prospect Reservoir) are shown in Figure 5.1 below.

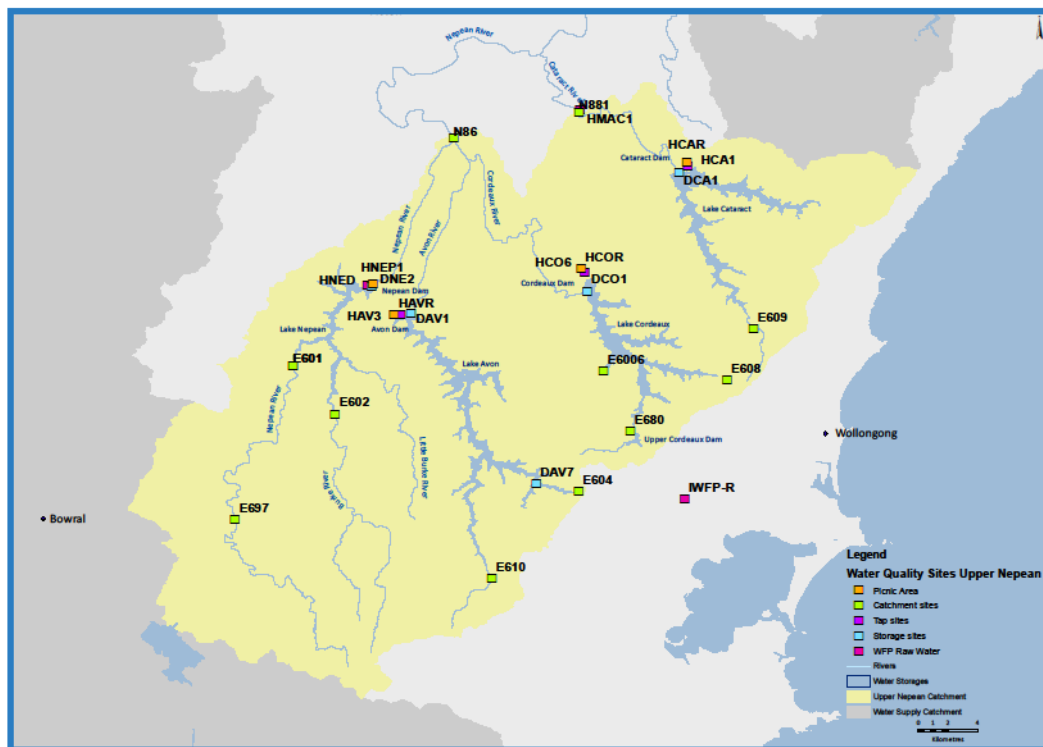
Figure 5.2: Sampling sites in the Upper Nepean system.

Sampling sites in the Upper Nepean system are shown in Figure 5.2 below.

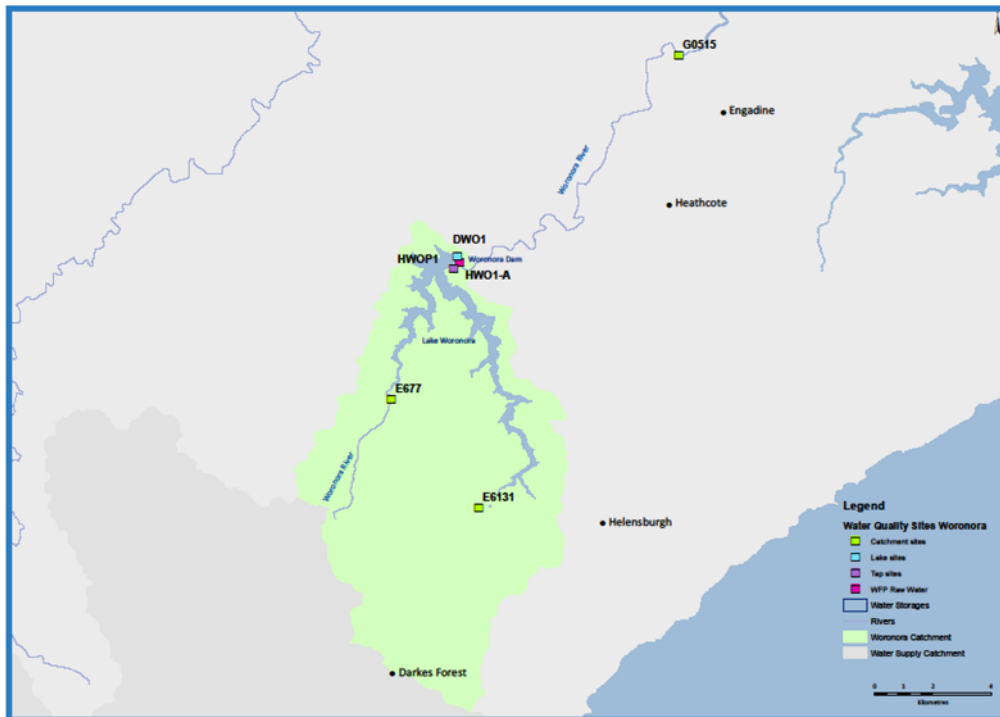
Figure 5.3: Sampling sites in the Woronora system.

Sampling sites in the Woronora system are shown in Figure 5.3 below.

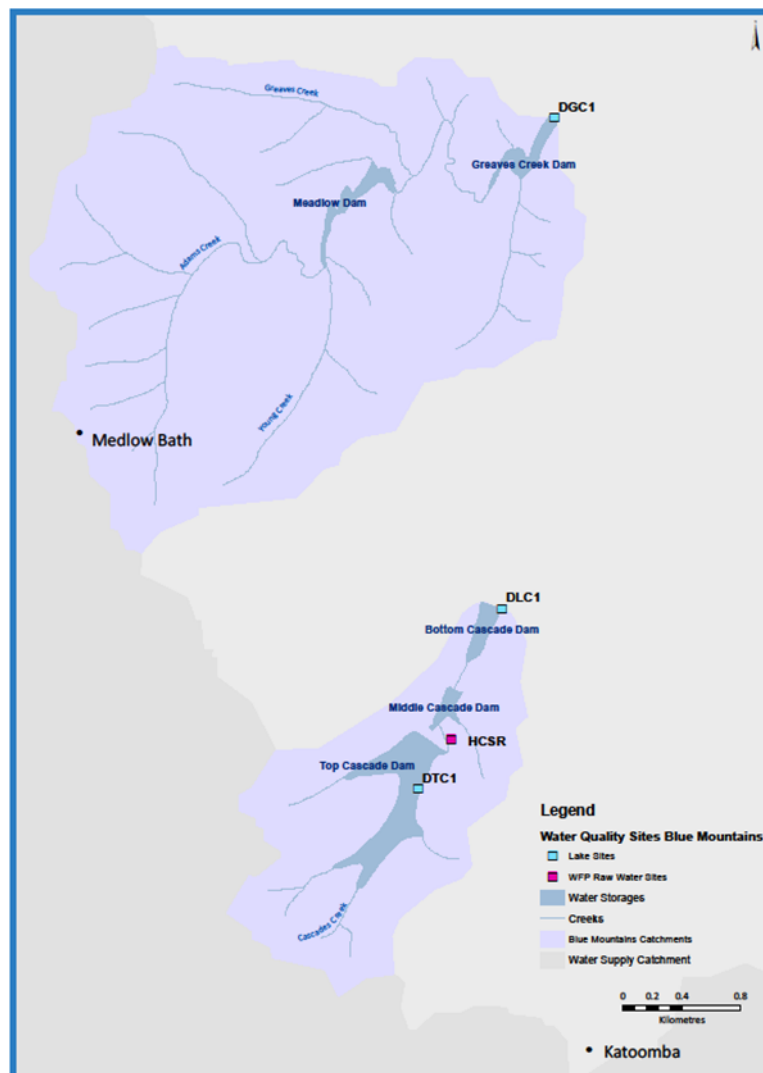
Figure 5.4: Sampling sites in the Blue Mountains system.

Sampling sites in the Blue Mountains system are shown in Figure 5.4 below.

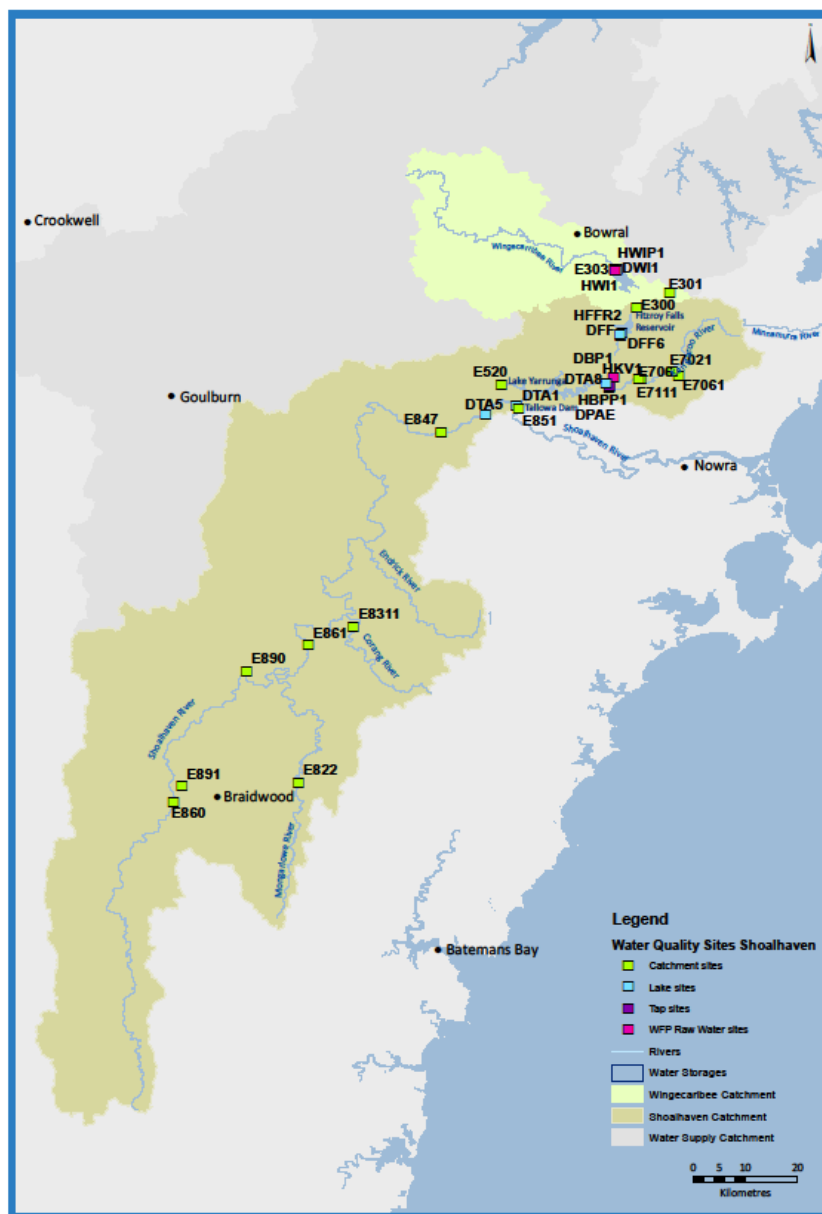
Figure 5.5: Sampling sites in the Shoalhaven system

Sampling sites in the Shoalhaven system are shown in Figure 5.5 below.

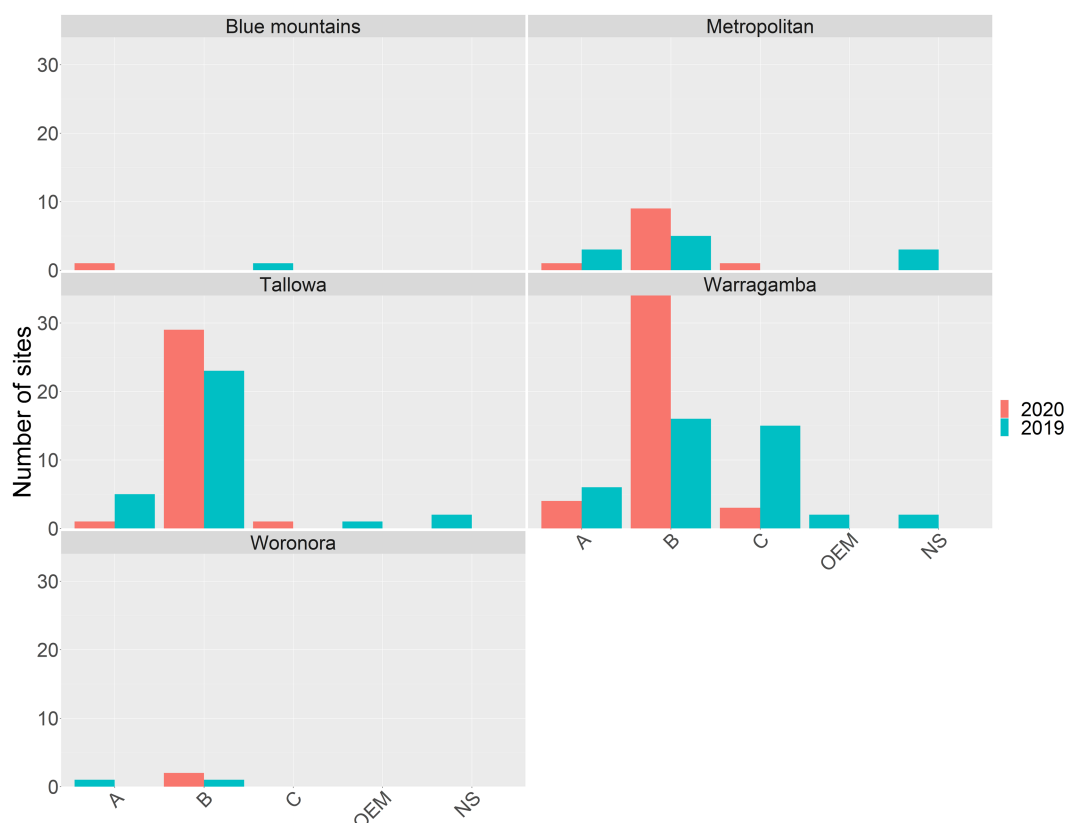
Figure 7.1 shows the distribution of 2020 and 2019 AUSRIVAS band grade ratings for each individual catchment. Of the 77 sites monitored in both 2019 and 2020, 43 received a lower AUSRIVAS score value in 2020, and 34 received a higher AUSRIVAS score. This suggests there was an overall decline in macroinvertebrate health across the declared catchment, although the change in OE50 score value at each site was not always large enough to result in a change of AUSRIVAS band grade.

Figure 7.1: Distribution of AUSRIVAS band grades for sites monitored in 2019 and 2020. Band grades are Above Reference (X), Reference (A), Below Reference (B), Well Below Reference (C), Outside experience of the AUSRIVAS model (OEM) or Not Sampled (NS).

Across the Warragamba, Tallowa, Metropolitan (Upper Nepean) and Woronora catchments, most sites in 2020 were rated as below reference (AUSRIVAS band B). Macroinvertebrate health improved in the Warragamba catchment in 2020, with 15 sites increasing, and seven sites decreasing by one band grade. There was an overall decline in macroinvertebrate health in the Tallowa and Metropolitan catchments, which had six and four sites moving to a lower band grade, respectively and no sites increasing in band grade. Both sites in the Woronora catchment declined by one band grade. The Blue Mountains catchment site improved by two band grades from 2019. Further site information and site-averaged AUSRIVAS scores are presented in Table 7.1.
