# Targeted Ecological Impact Assessment

## Greater Sydney Rockfall Stabilisation Program - Nepean Dam (Site 005D)

Water NSW

28 February 2023

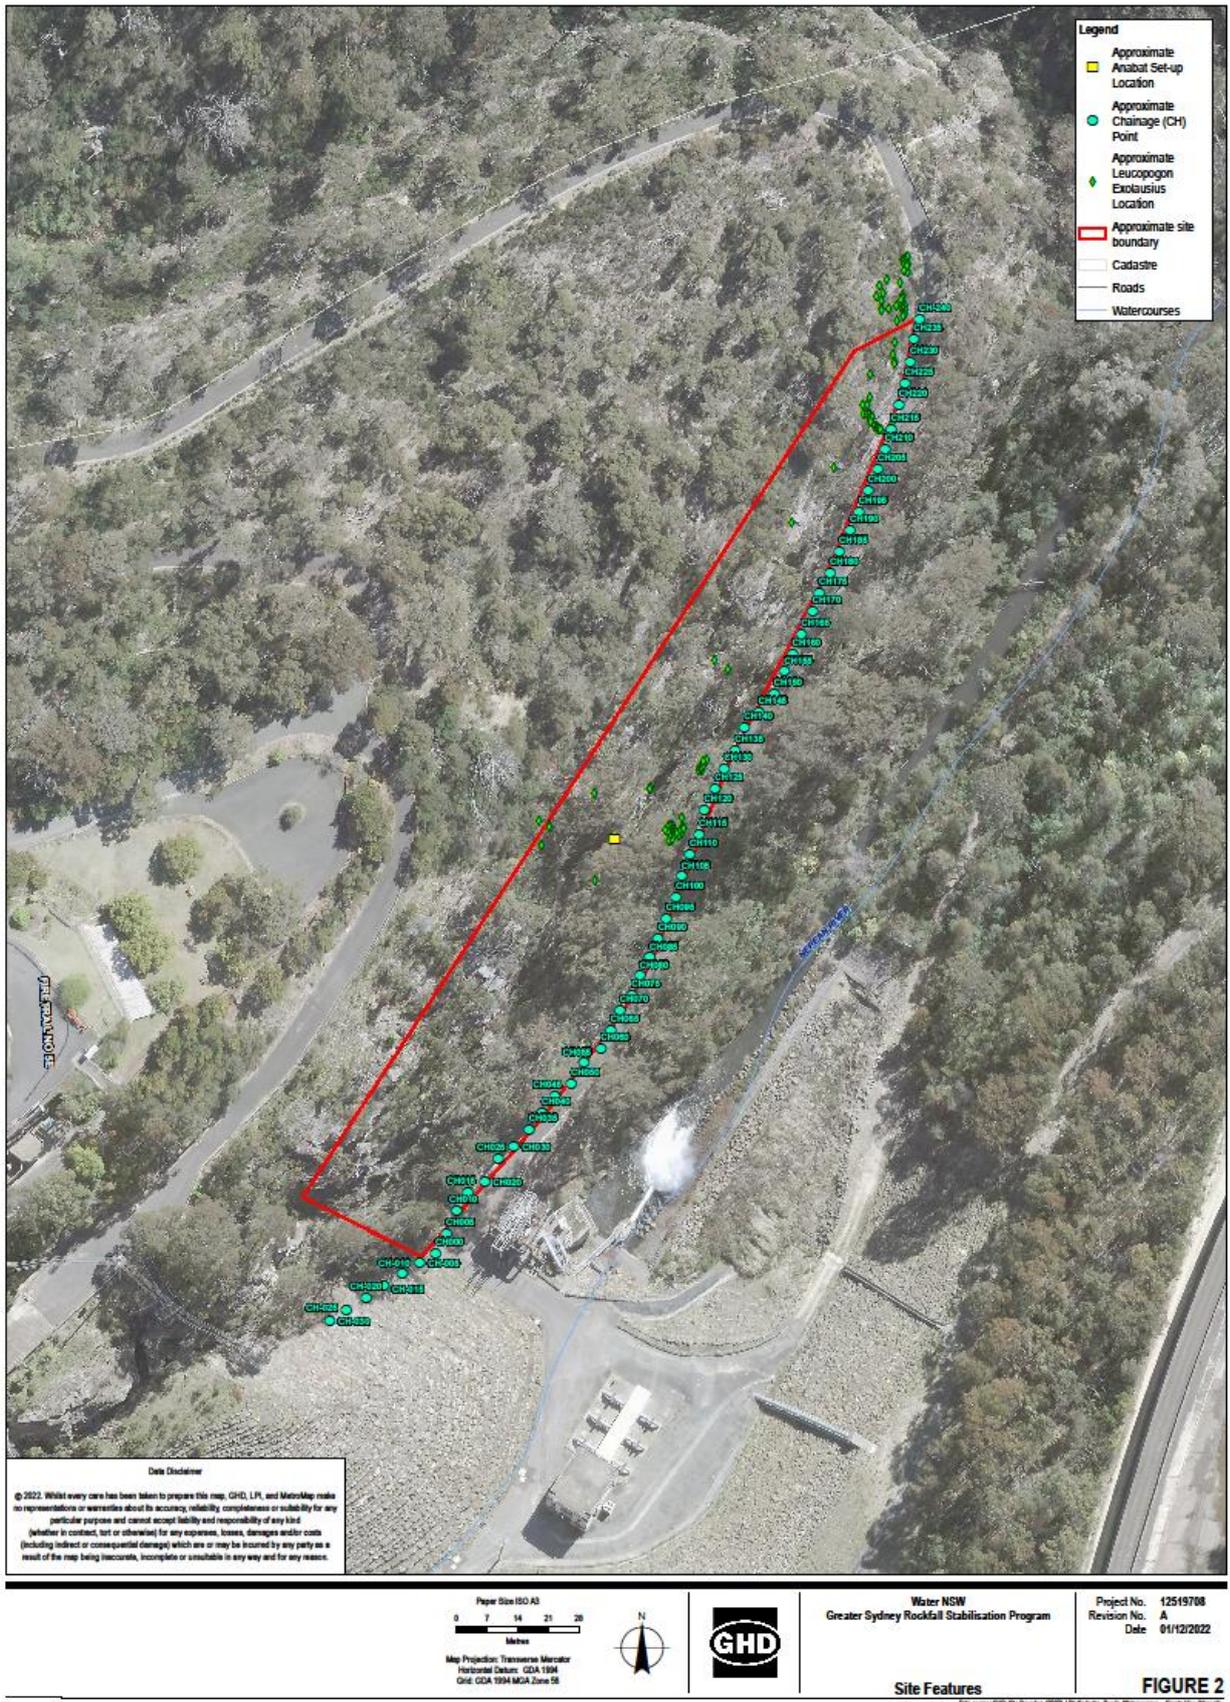
Figure 2 Locations of *Leucopogon exolasius* and Anabat recording device at Site 005D

A total of 118 *Leucopogon exolasius* individuals were recorded in and immediately surrounding Site 005D (i.e. in areas that might be used for access to Site 005D). It is noted that most individuals were located in two areas, with one being located north, outside of Site 005D, and the other located in Site 005D. All other individuals were spread across the site, with most located in the northern and central portions, and only a small number located in the southern portion.

As mentioned in Section 1, it is understood that the remediation works may be completed in sections (chainages) to mitigate against impacts to flora (if required). It is noted that no individuals were recorded in the first stage of works (i.e. CH-25 to CH35), with all individuals recorded in the remainder of Site 005D (i.e. CH35 to CH250), as shown on Figure 2.

It is noted that of the individuals recorded, 39 were reported between CH230 to CH240. It is understood that most of these individuals were located outside (upgradient) of the proposed remediation areas, as such, no remediation works, or disturbance, is proposed for the individuals in this location.

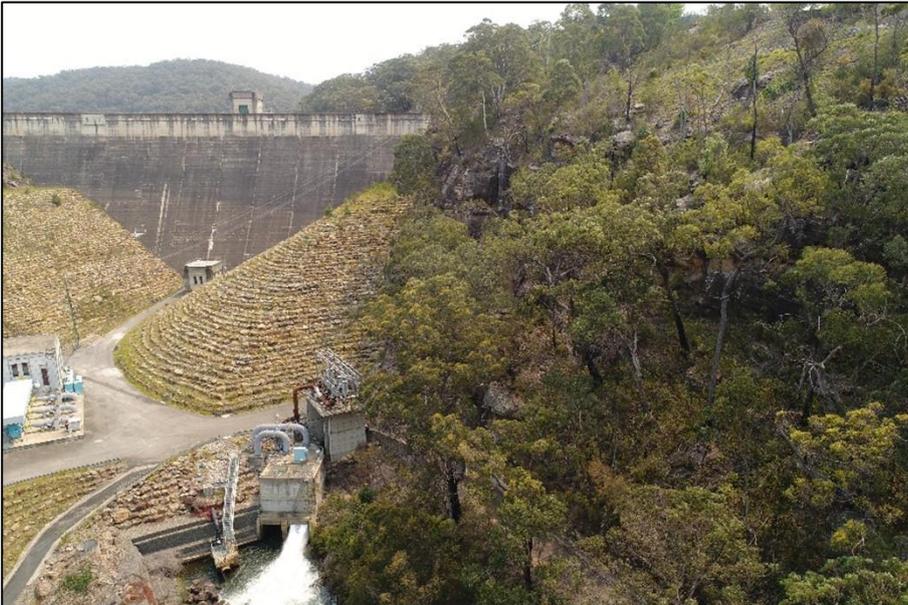
*Photo 1 View of the southern portion of Site 005D (facing south) showing the steepness of the embankment*

A series of stepped and broken cliff lines extend upwards above the colluvial slopes with shear rock faces up to about 20 m high. Several prominent sandstone overhangs are formed within the upper sections of cliff-line.

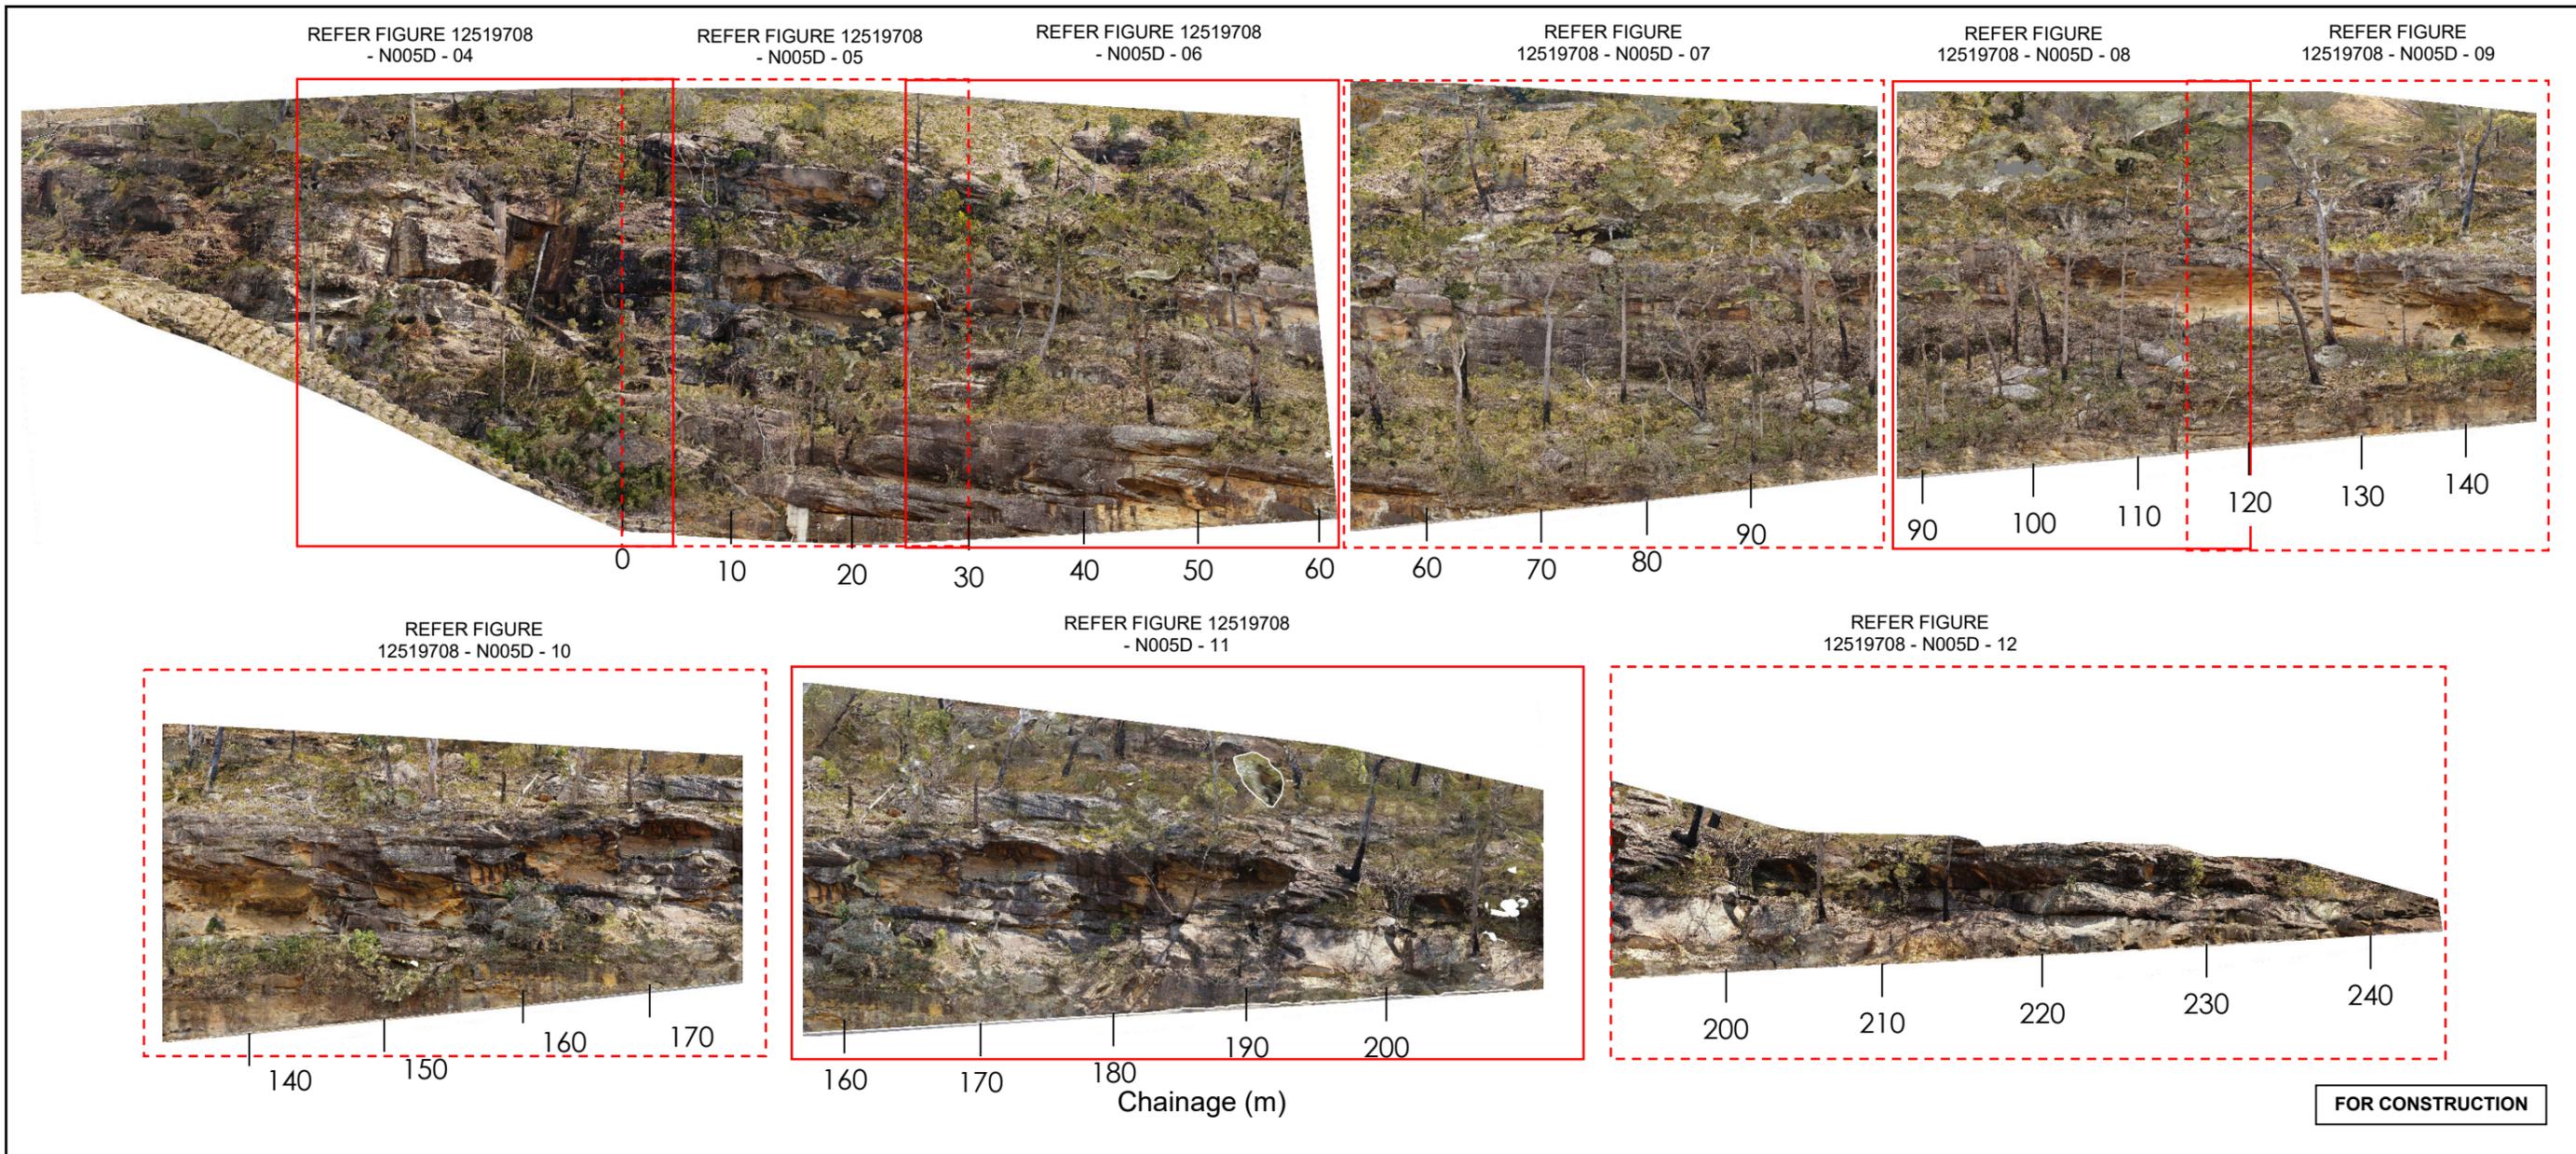
Title: **Slope Stabilisation Treatment Photomosaic Sheet 1 of 10**  
 Mapped By: DF, KD & AH    Checked By: DF    Date: 24/08/2022  
 Figure No. 12519708 - N005D - 03

**TARGETED SCALING, TREE-LOPPING, SHOTCRETE & MESH CONSTRUCTION**

- N01 **Rockfall Hazard Feature ID**  
Refer hazard feature ID description sheets for details
- Scaling and Grooming**      **Tree-logging/ Devegetation**  
Areas requiring selective scaling and grooming as directed to remove loose or detached rock masses or soil accumulations.
- Shotcrete (structural)**  
Locations requiring application of mesh reinforced shotcrete
- Pinned Rock Fall Mesh**  
Selected boulder and block wall hazards requiring in-situ support via pinned mesh

1. Ortho-photomosaic subject to parallax distortion effects. Do not scale. Extent of hazard features and work boundaries are approximate.
2. Refer to Sheets 2 to 10 for close-up views of slope and proposed stabilisation details.
3. Refer to cutting reference chainages marked along toe of rock slope.
4. Alpha numeric labels (eg: N01) denote individual slope hazard features - refer to description sheets for more details.
5. All trees/saplings growing on rock face are to be removed and stumps poisoned (Refer Project Specification).
6. Systematic scaling of all loose rock material to be carried out across entire rock face and upper slope using hand tools (Refer Project Specification).
7. Locations of specialist treatment (rock bolts/ shotcrete/ mesh) to be confirmed by GHD representative, installation as per Project Specification.

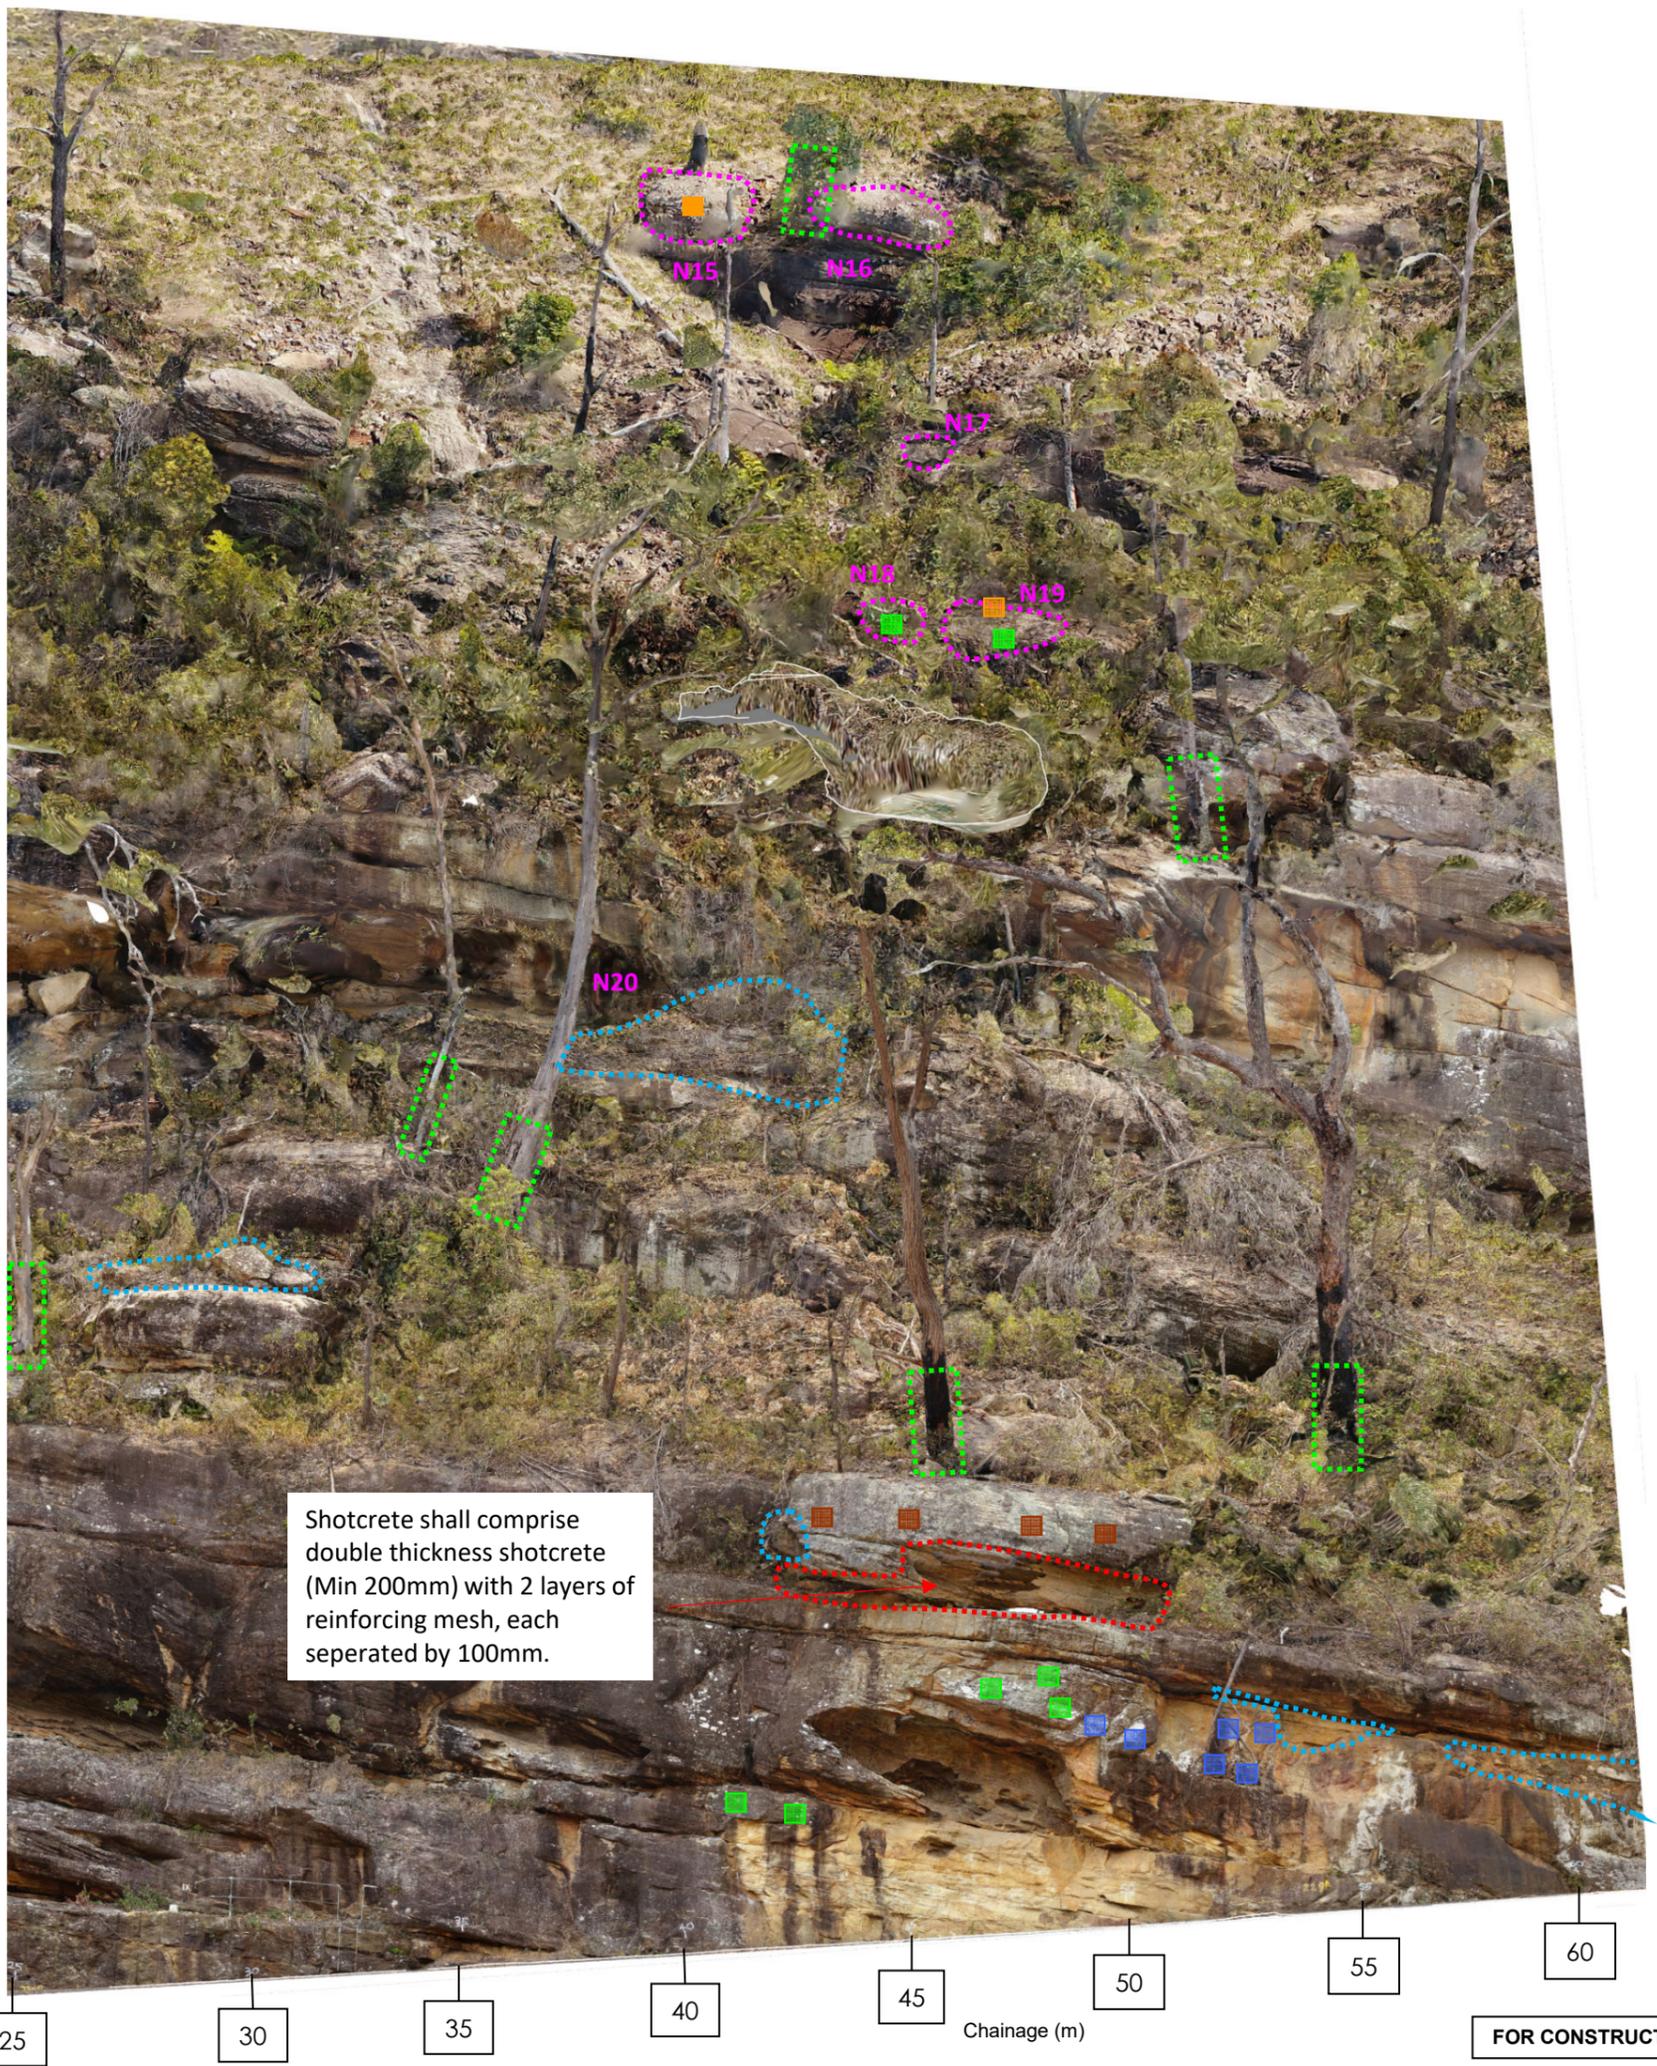
Shotcrete shall comprise double thickness shotcrete (Min 200mm) with 2 layers of reinforcing mesh, each separated by 100mm.

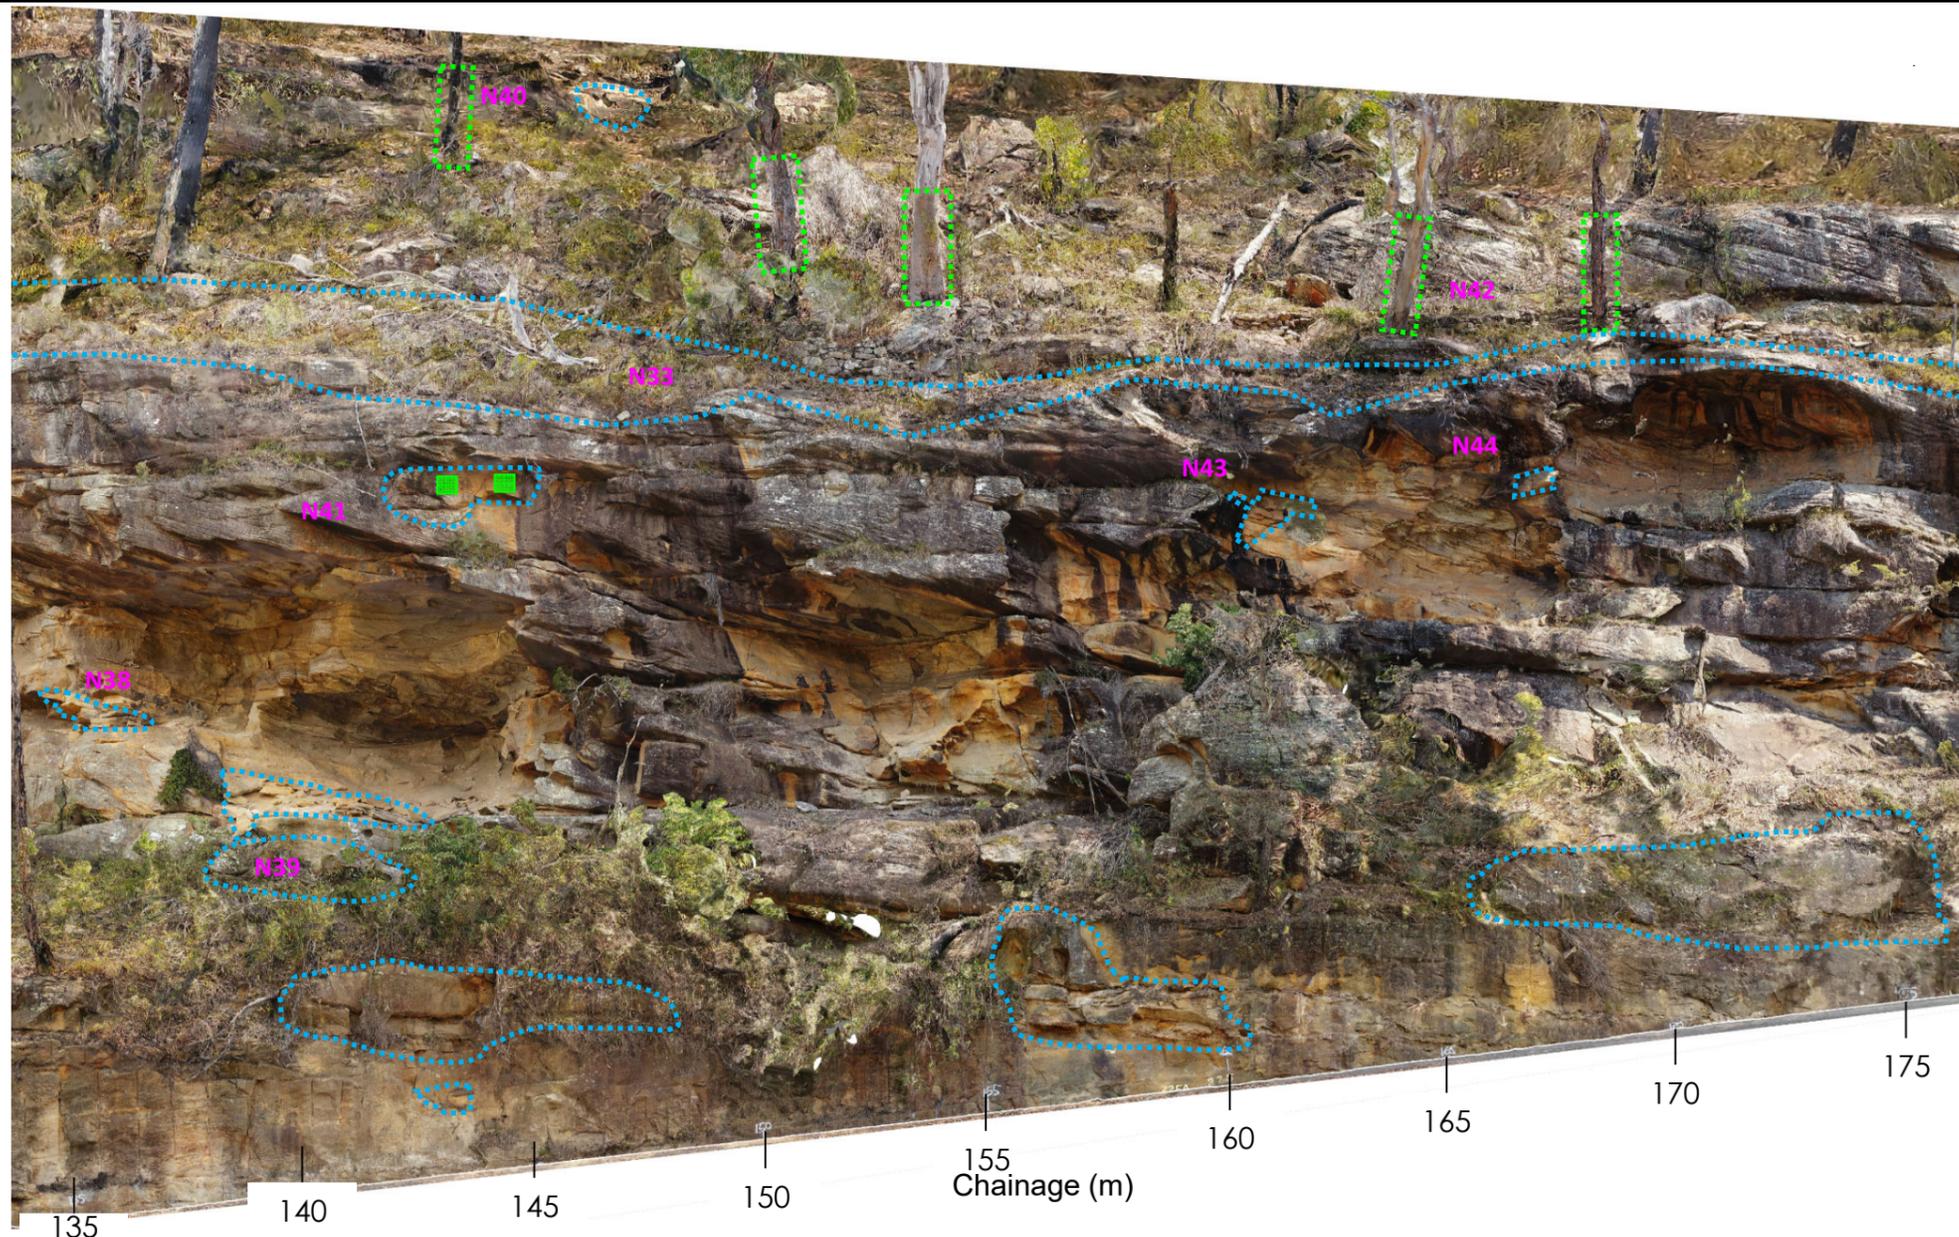
Title: **Slope Stabilisation Treatment Photomosaic**  
**Sheet 8 of 10**  
 Mapped By: DF, KD & AH Checked By: DF Date: 24/08/2022  
 Figure No. 12519708 - N005D - 10

**TARGETED SCALING, TREE-LOPPING, SHOTCRETE & MESHING WORKS**

- N01 **Rockfall Hazard Feature ID**  
Refer hazard feature ID description sheets for details
- Scaling and Grooming**   **Tree-logging/ Devegetation**  
Areas requiring selective scaling and grooming as directed to remove loose or detached rock masses or soil accumulations.
- Shotcrete (structural)**  
Locations requiring application of mesh reinforced shotcrete
- Pinned Rock Fall Mesh**  
Selected boulder and block wall hazards requiring in-situ support via pinned mesh

1. Cropped ortho-photomosaic subject to parallax distortion effects. Do not scale. Extent of hazard features and work boundaries are approximate.
2. Refer to Sheet 1 for location of this sheet in ortho-photomosaic of entire slope. Cutting reference chainages marked along toe of rock cutting.
3. Alpha numeric labels (eg: N01) denote individual slope hazard features - refer to description sheets for more details.
4. All trees/saplings growing on rock face are to be removed and stumps poisoned (Refer Project Specification).
5. Systematic scaling of all loose rock material to be carried out across entire rock face & upper slope using hand tools (Refer Project Specification).
6. Locations of specialist treatment (rock bolts/ shotcrete/ mesh) to be confirmed by GHD representative, installation as per Project Specification).

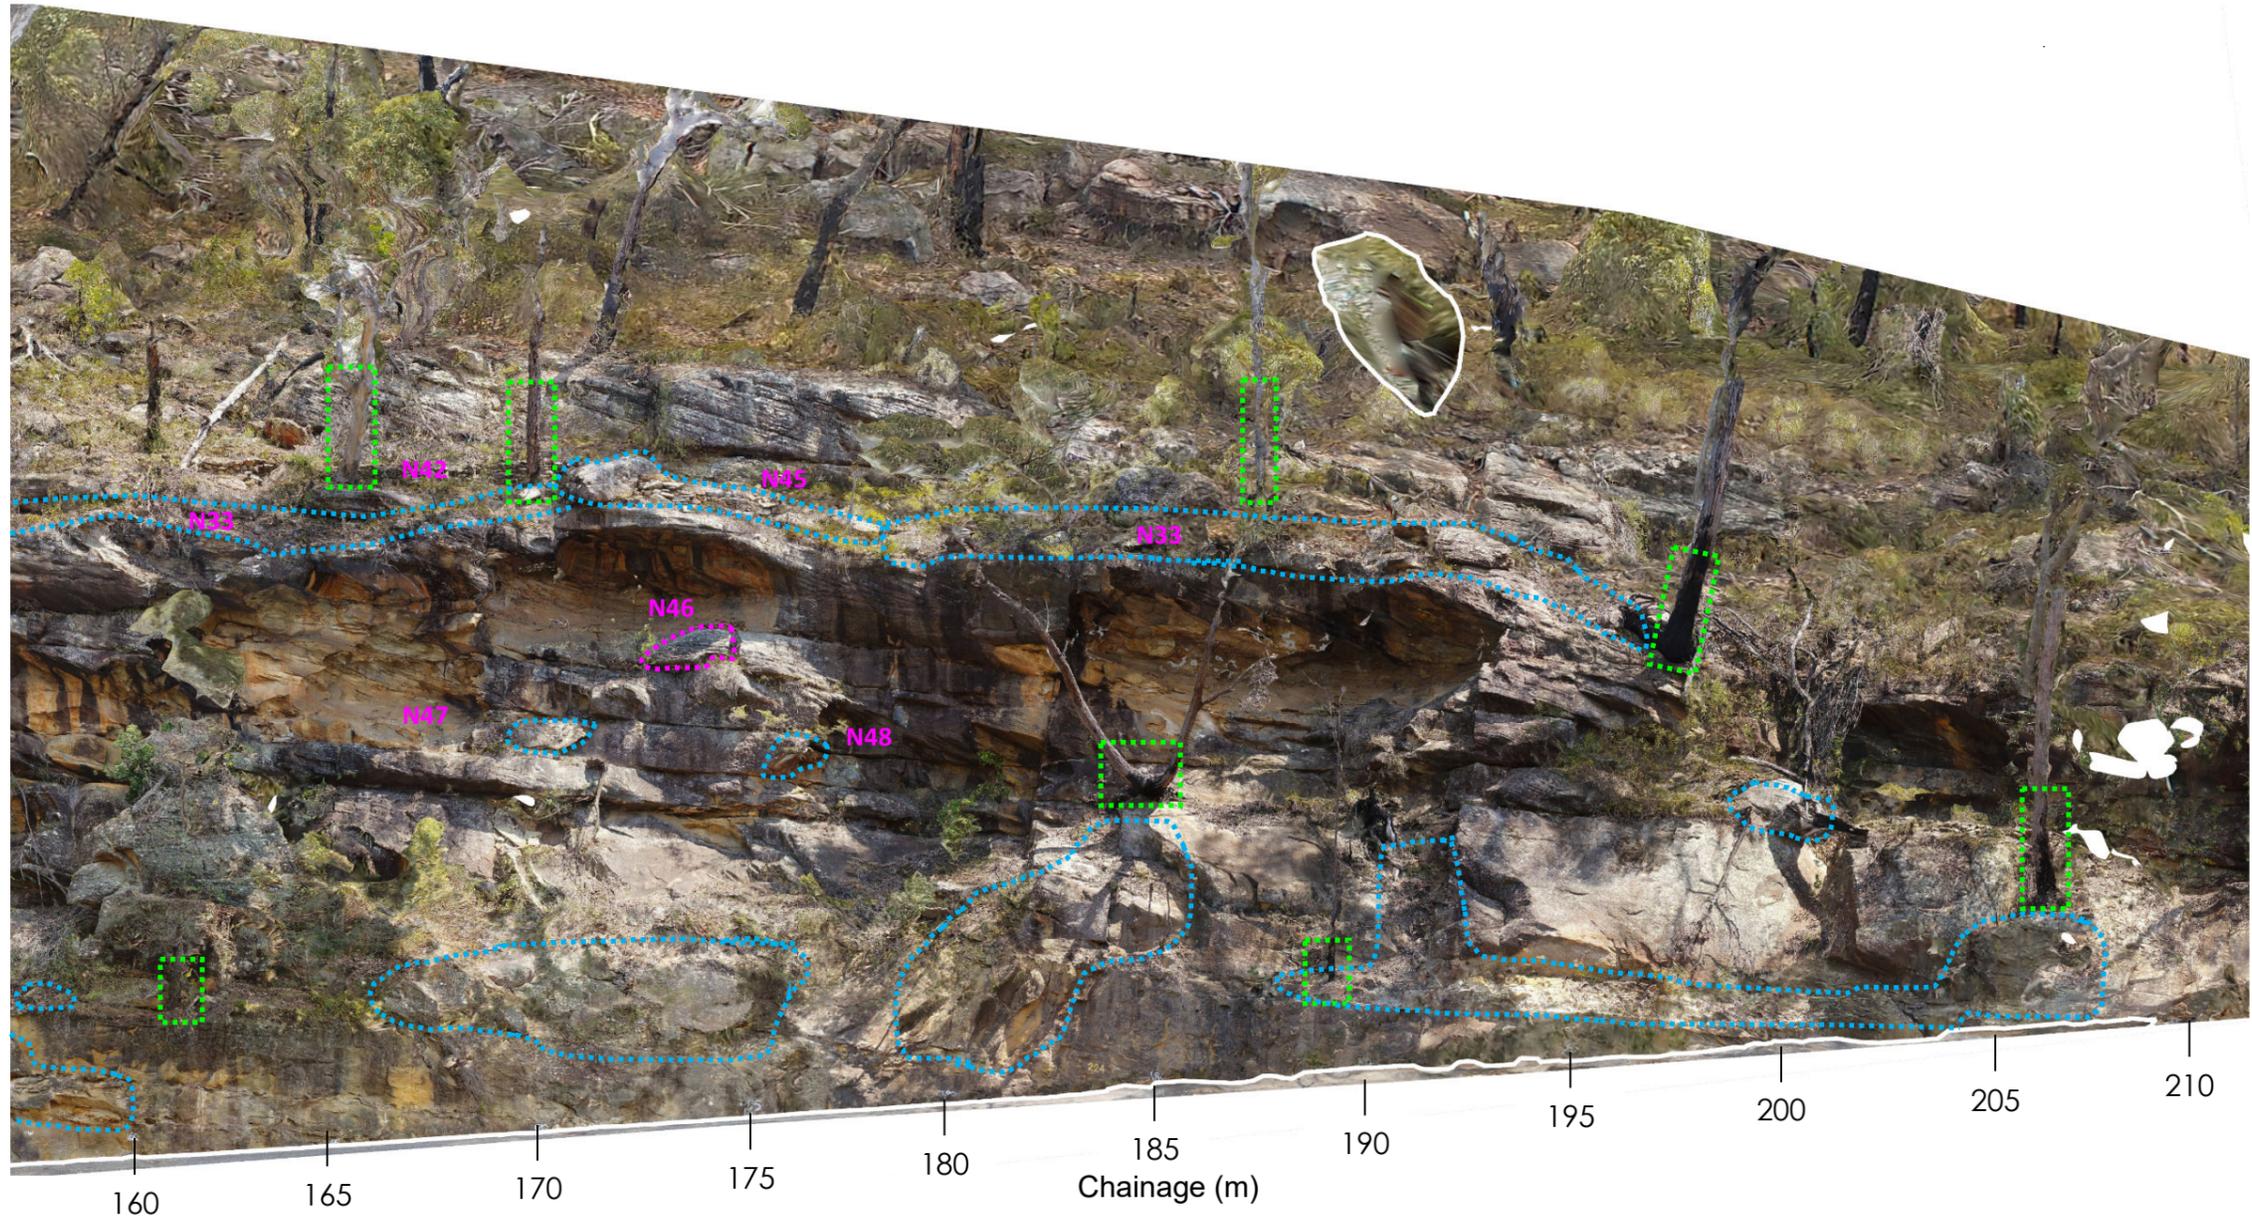
Title: **Slope Stabilisation Treatment Photomosaic Sheet 9 of 10**  
Mapped By: DW, KD & AH Checked By: DF Date: 24/08/2022  
Figure No. 12519708 - N005D - 11

**TARGETED SCALING, TREE-LOPPING, SHOTCRETE & MESHING WORKS**

**N01 Rockfall Hazard Feature ID**  
Refer hazard feature ID description sheets for details

**Scaling and Grooming** **Tree-logging/ Devegetation**  
Areas requiring selective scaling and grooming as directed to remove loose or detached rock masses or soil accumulations.
