State of the Special Areas

Report 2019-22

Executive summary

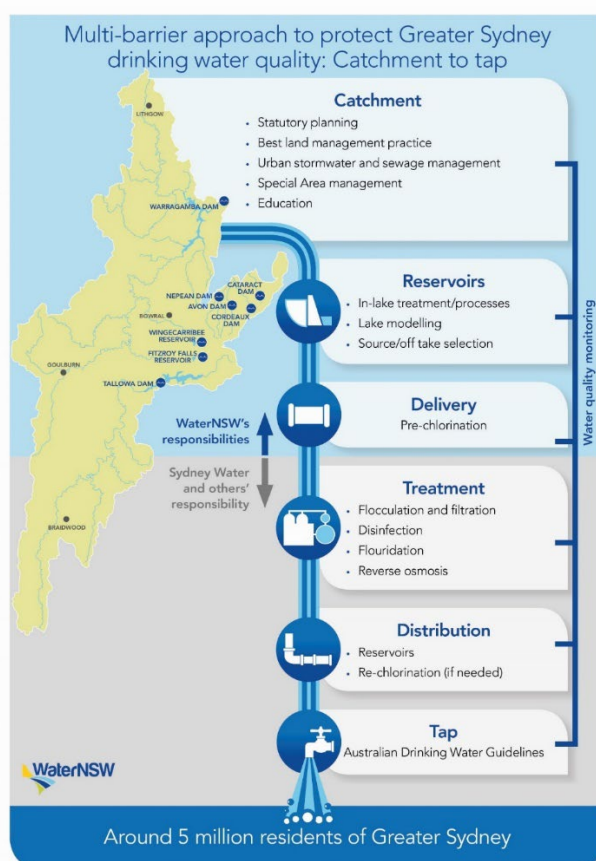
Figure 11: Multi-barrier approach to protect Greater Sydney drinking water quality (source: WaterNSW)

Elements of the multiple barrier approach are illustrated in Figure 11 and include:

- monitoring and influencing land use, development and activities across the catchment
- establishing, maintaining and managing Special Areas and Controlled Areas around water storages and water supply infrastructure, where human access or certain activities are restricted
- reservoir management
- water treatment and distribution.

As shown in Figure 11, Special Areas management is an integral part of the approach to protect Greater Sydney drinking water quality.

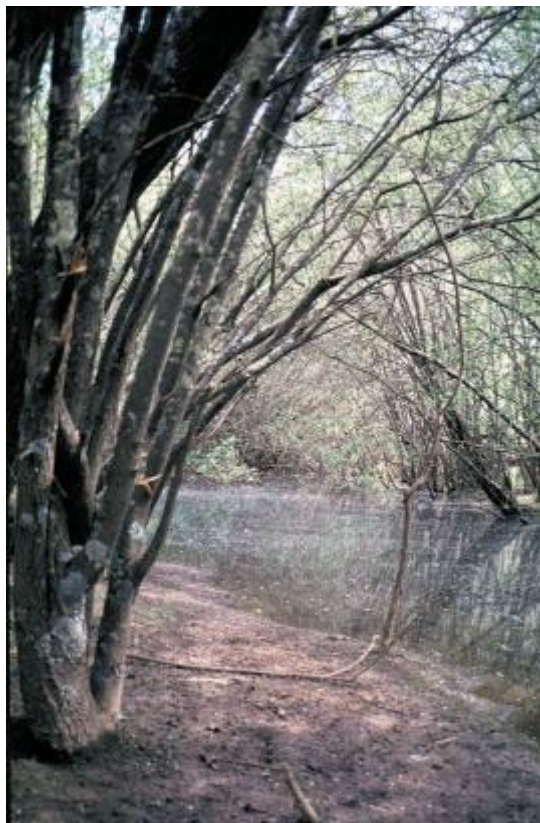
Figure 15: Willows (photo: NSW Department of Primary Industries)

Willows are among the worst weeds in Australia due to their invasiveness, potential for spread, and economic and environmental impacts. They are a Weed of National Significance and listed as a State and Regional Priority Weed in both plans. They have invaded riverbanks and wetlands in temperate Australia, occupying thousands of kilometres of streams and numerous wetland areas. Unlike most other vegetation, willows spread their roots into the bed of a watercourse, slowing the flow of water and reducing aeration. They form thickets which divert water outside the main watercourse or channel, causing flooding and erosion where the creek banks are vulnerable. Willow leaves create a flush of organic matter when they drop in autumn, reducing water quality and available oxygen. This, together with the amount of water willows use, damages stream health.
