Annual Water Quality Monitoring Report

2018-19

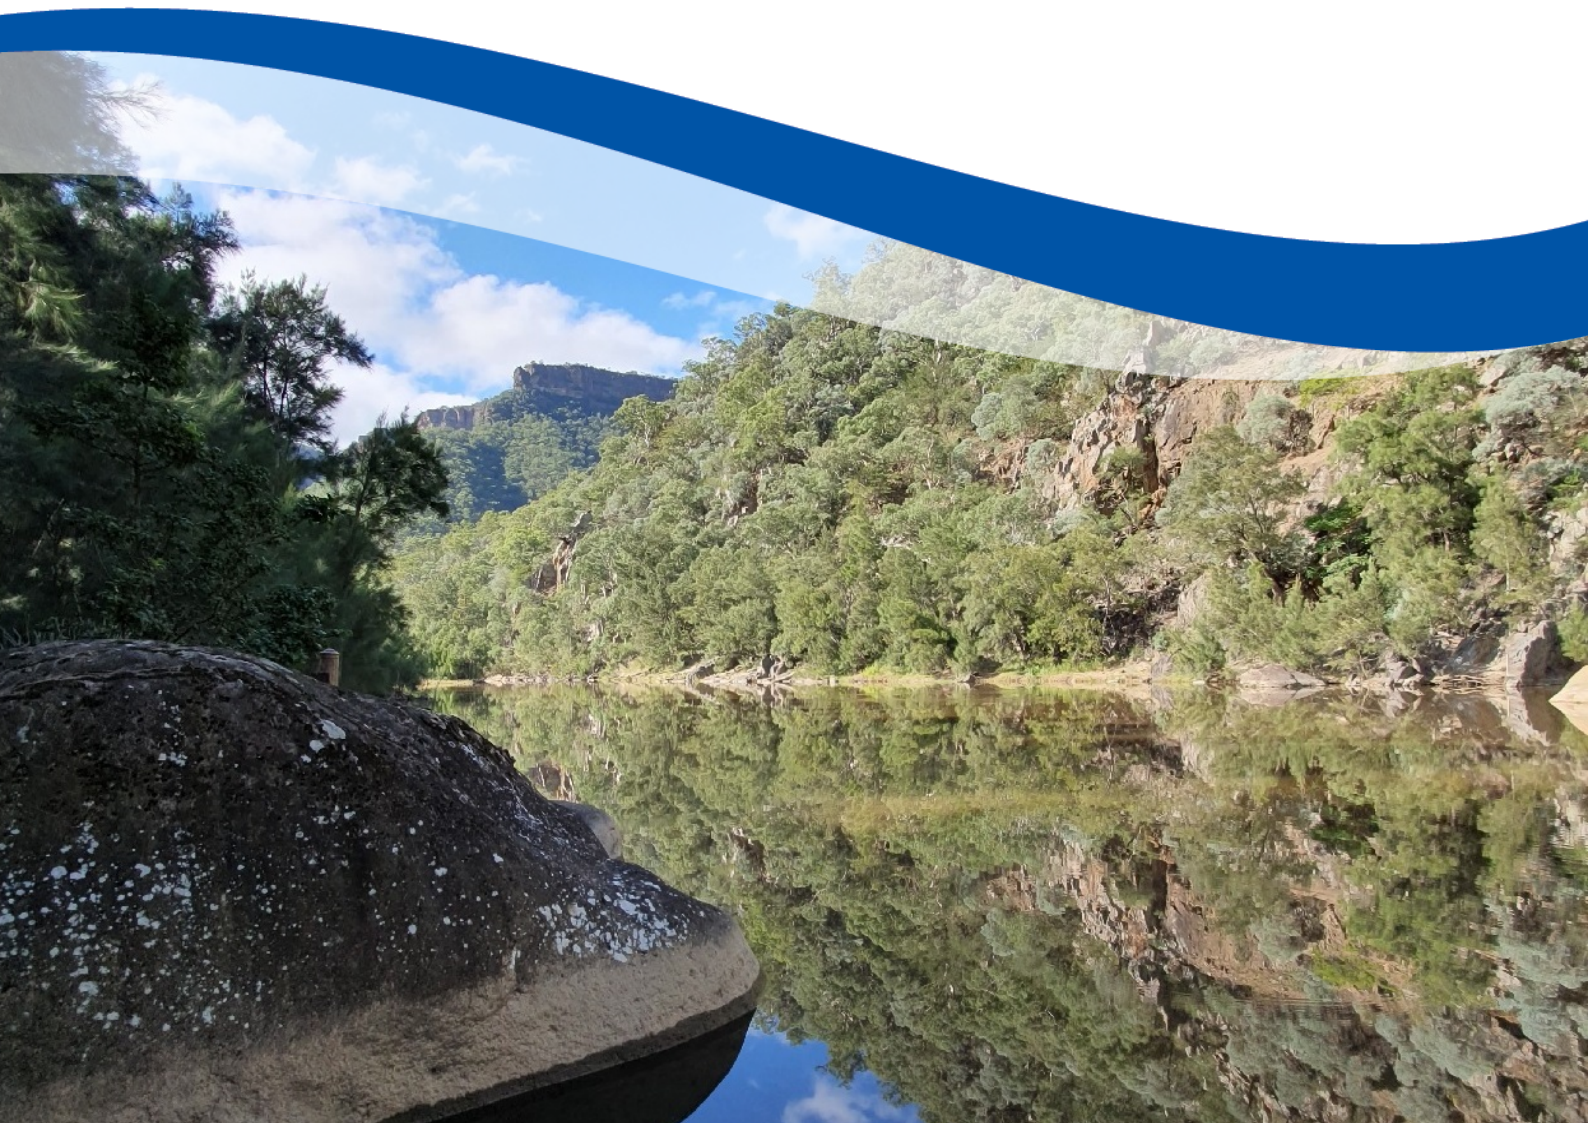
Figure 0.1: Sydney catchment area

The catchments cover an area of approximately 16,000 square kilometres, extending from the headwaters of the Cocks River north of Lithgow, south to the source of the Shoalhaven River near Cooma, and from Woronora in the east to the Wollondilly River near Crookwell in the west (Figure 0.1). Raw water is collected from the river systems of five major catchments:

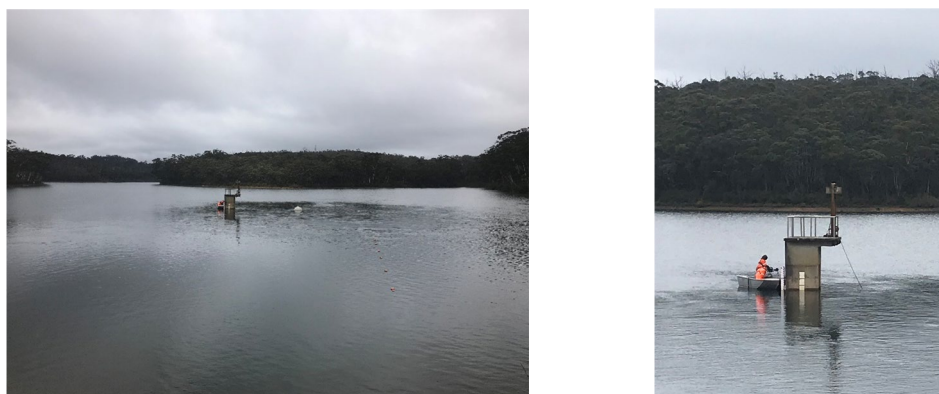
Figure 7.1: Water monitoring in Top Cascade Lake on 25 October 2018.

The higher risk period for geosmin production in the Blue Mountains is summer and autumn. Geosmin monitoring commenced in September 2018 in the Blue Mountains storages to identify any rising trends for the 2018/19 season. Initial monitoring in Top Cascade Lake (see Figure 7.1) reported geosmin at concentrations ranging from 8.1 to 9.6 ng/L. These concentrations were higher than typical for the lake and were above the odour thresholds. Elevated concentrations persisted into October and peaked at 15.7 ng/L. To identify the microorganisms contributing to the geosmin a next generation sequencing approach targeting the 16S rRNA SSU (a universal gene conserved across all prokaryotes) was employed.

The 16S rRNA method provides a community profile of bacteria, indicating the presence and relative abundance of bacterial populations in the lake water. Water samples were collected on 25 October, 1 November and 8 November 2018 for DNA extraction and 16S rRNA sequencing. During this period the geosmin concentrations remained elevated in Top Cascade Lake and relatively lower in Lake Greaves and Lower Cascade Lake. The bacterial community profiles revealed that bacterial species belonging to the Actinobacteria phylum constituted between 15-25% of bacterial communities in Top Cascades Lake, compared to 0.2-5% at Lake Greaves and Lower Cascades Lake. The high relative abundance of Actinobacteria in Top Cascade Lake indicated that the geosmin production was linked to the Actinobacteria. This information can be used to increase understanding of the ecological processes driving geosmin production which will assist in forecasting water quality changes and risks to aesthetic quality of the raw water supply in the Blue Mountains lakes.
