4.6 Common technical issues

4.7 Case study

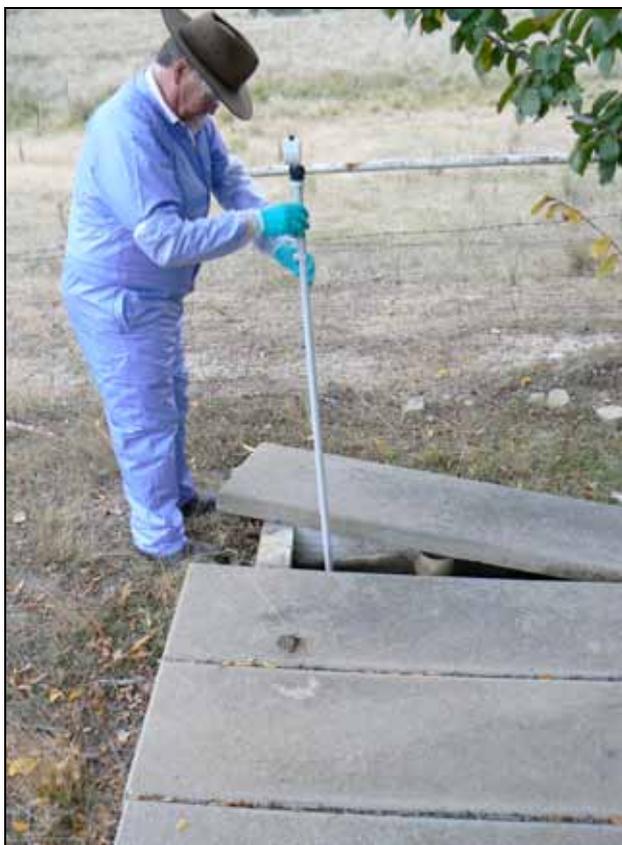
Sludge accumulation in septic tank chambers should be inspected regularly as part of the maintenance schedule and the sludge depth measured with an appropriate device (Figure 4.6). Guidance on the frequency of sludge removal is provided in AS/NZS 1547:2012. Sludge removal should be undertaken by an experienced and licensed contractor.

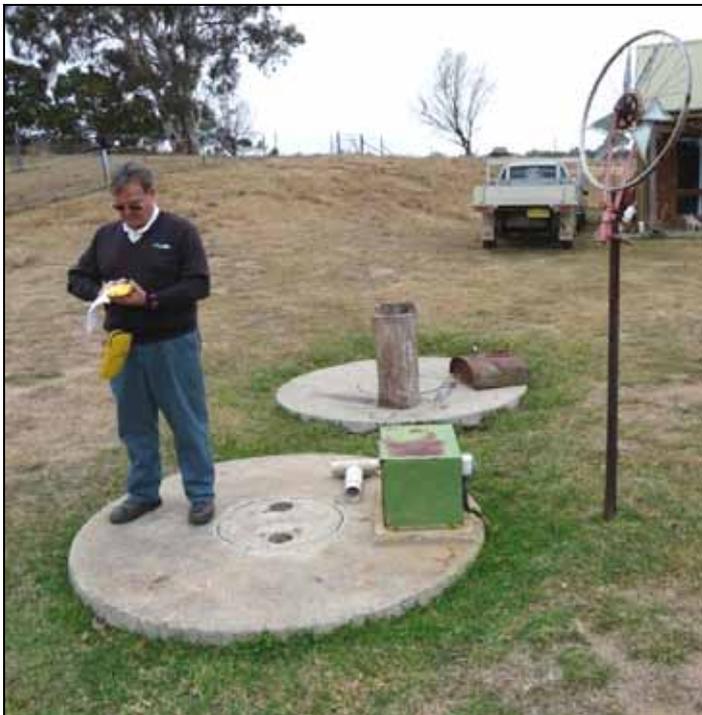
Figure 4.7

Both figures – Low installation locations, no stormwater diversion berm / drain and inadequate sealing of lid to tank leading to stormwater inflows

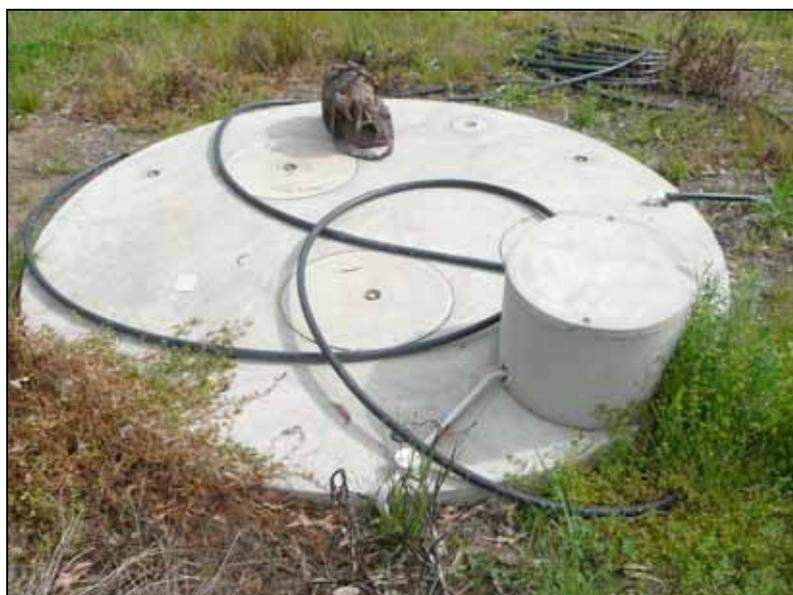
The tanks were positioned in the correct location on-site but the lids were not sealed to prevent stormwater entering and the lid was level with the ground surface on the upslope side of the tank. A black poly hose was coiled over the top of the tank with two butterfly sprinklers left in the pump box on the top of the tank (Figure 4.9). The approved plans for the system indicated that there would be 400 square metres of surface spray irrigation installed according to buffer distances from the dwelling and a nearby intermittent drainage line.

Figure 4.9 New AWTS with irrigation hose coiled on top, no sprinklers and potential for stormwater inundation

- Install the AWTS and irrigation system as needed by the council approval (the installer of the wastewater and effluent disposal system must be provided with the relevant conditions of consent)
- install a surface water diversion drain around the top of the tank to divert all upslope surface water runoff away from the tank
- seal around the lid of the tank to ensure stormwater water cannot enter the system
- system installers should liaise with builders and property owners about outstanding work needed for the system to comply with council approvals.
